**Adopted solutions on production:****Step 1 – Temporary solution**

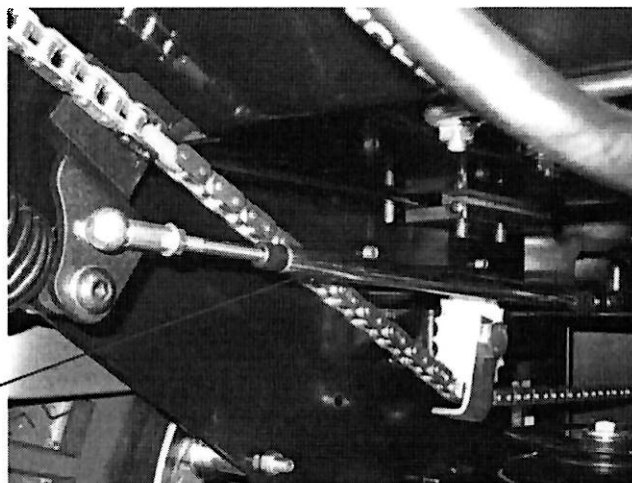
reinforcement pipe  
p/n 137869111/0

A temporary solution was adopted on machines produced from end of June 2015 from serial number 150617047Z by adding the metal pipe p/n 137869111/0 working as cable reinforcement. This solution was previously announced with Service Bulletin FM-039 and has been replaced by the final solution described on step 2.

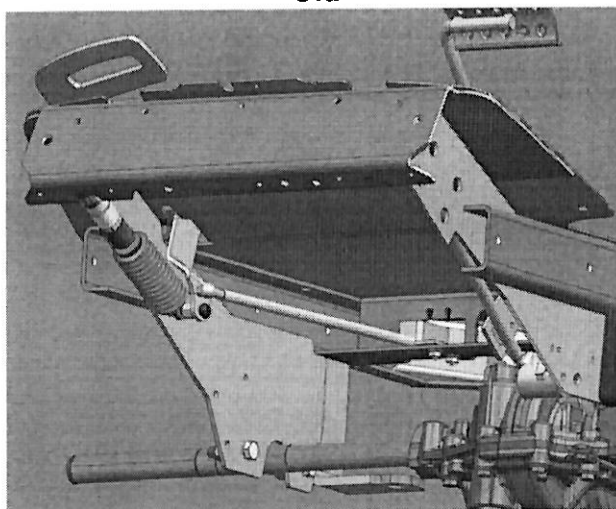
**Old**

The new solution does not require anymore the use of the reinforcement pipe p/n 137869111/0. Below drawings show the difference between old and new solution.

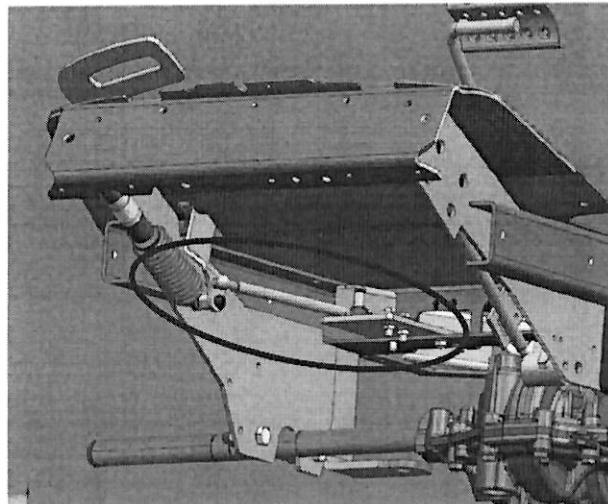
**New**

As final solution, the machines produced from November 2016 with serial number higher than 161102011Z have a new speed cable p/n 187000210/0 with a mounting system preventing the rigid end of the cable from bending.
